## **Limited Visual Dam Safety Inspection Summary Report**

**HI - 00043**

**Puukapu Watershed Retarding Dam R-1**

**May 2006**

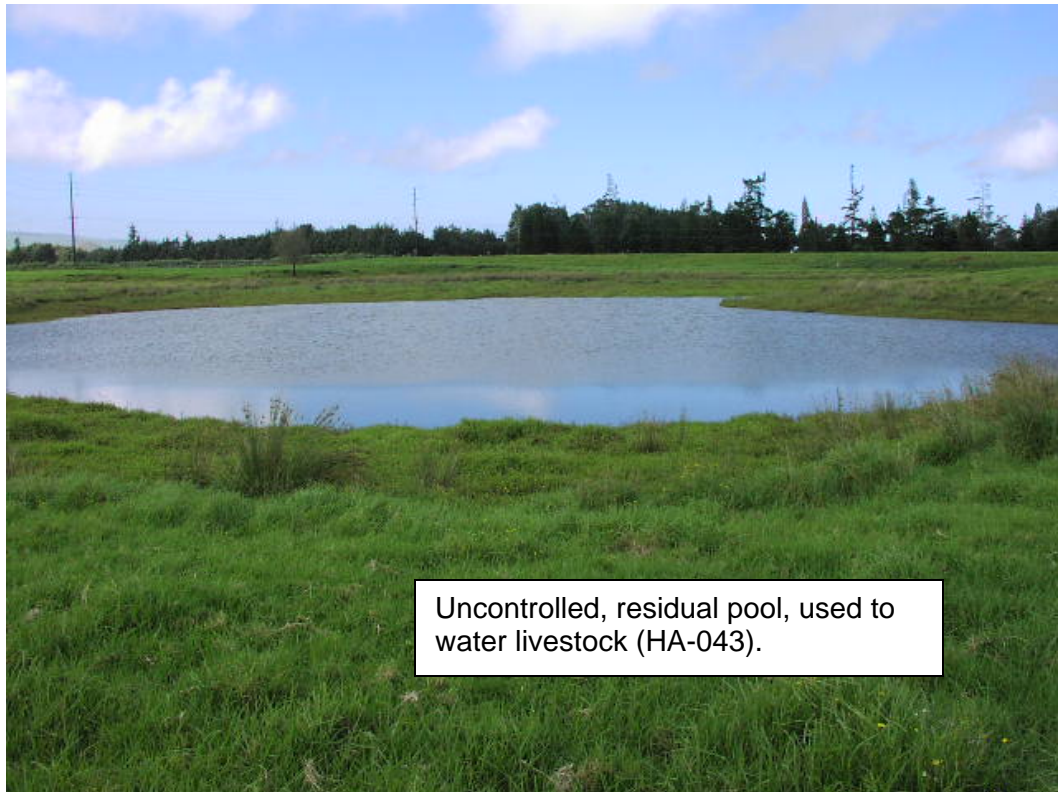
Uncontrolled, residual pool, used to water livestock (HA-043).

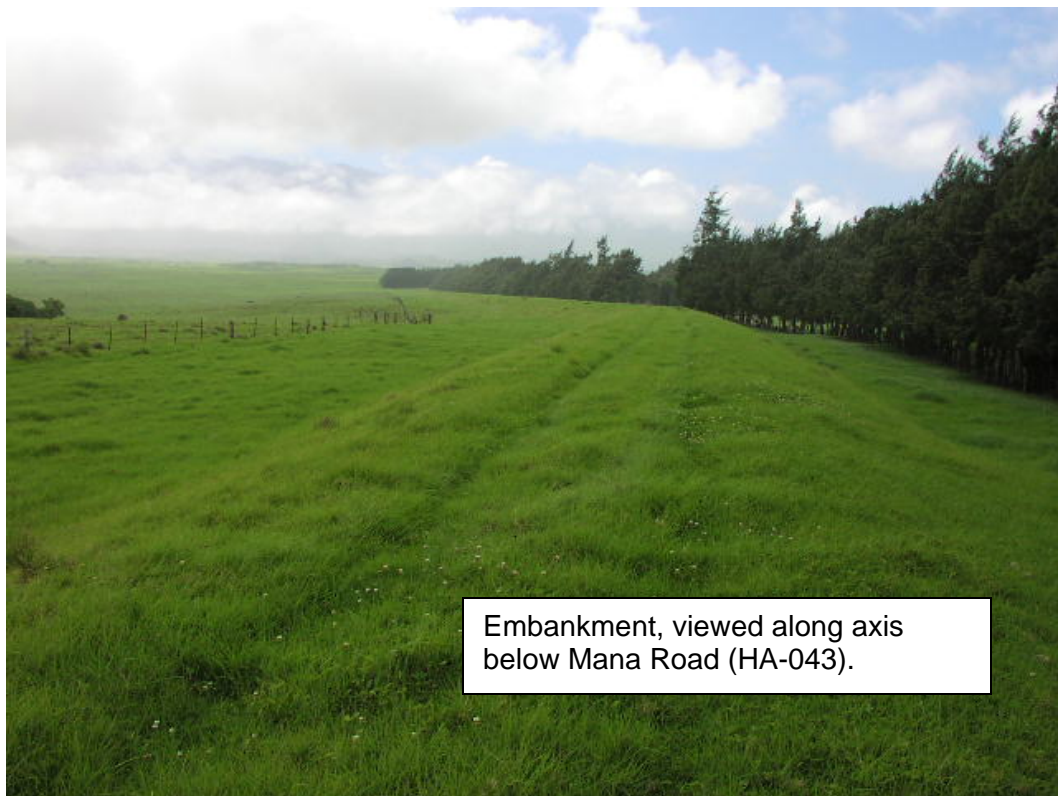
Embankment, viewed along axis below Mana Road (HA-043).

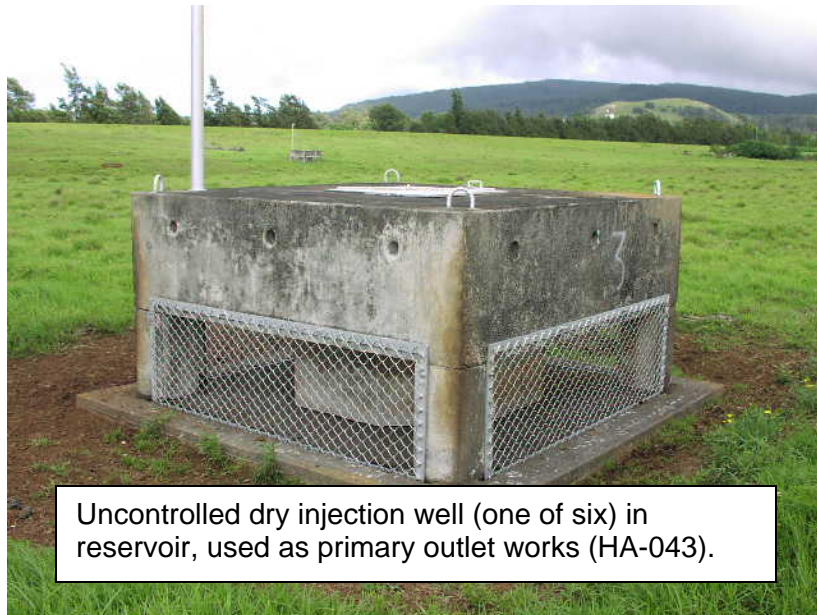
The primary outlet works consisted of a pattern of six dry injection wells, which are 2 ft 6 inch diameter pipes covered by a concrete screen box. None were flowing at the time of inspection. Screens around all were clear of any obstructions (apparently livestock that congregate at the boxes tramples the vegetation. The outlet works are uncontrolled, except by inlet (pipe) size. Seepage was not observed.

Uncontrolled dry injection well (one of six) in reservoir, used as primary outlet works (HA-043).

**Recommend installation of gage at one of the injection wells.**

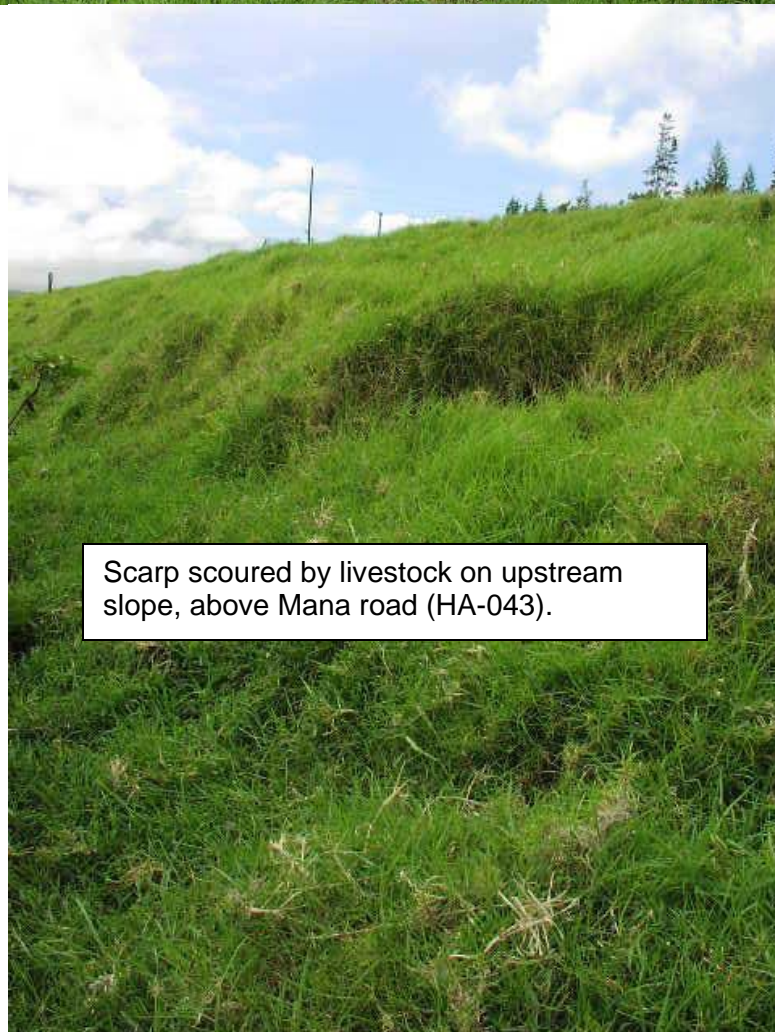
No slope protection was observed on the upstream slope other than well-established, uniform long grass. No erosion was observed, however, livestock have scoured a few scarps on the upstream slope, and these will erode in future rainfall. Cracks were not observed. Sinkholes were not observed.

- a. The upstream slope appeared to be in fair to poor condition and requires corrective action.
- b. Rut and/or gully erosion was observed on the slope, which requires maintenance and/or repair. Corrective action required is to repair scour by livestock, re-establish grass cover, and restrict livestock access to the slope.

Upstream slope: Please provide information on the erosion, cracks, sinkholes and vegetation that you observed. **A single, approximately 3 ft tall by 10 ft wide scarp was noted and photographed as shown in the report. This scarp was caused by cattle traffic and digging, perhaps by the horns of one of the longhorn cattle that had access to the slope at this point. Access should be restricted.**

Scarp scoured by livestock on upstream slope, above Mana road (HA-043).

**Grass should be kept mowed and slope distress repaired and reseeded.**

**The dam is not abandoned; rather, it's purpose is control of intermittent high inflow from the diversion ditch, which was not flowing at the time of the inspection. The reservoir is well-maintained; the only repairs indicated are to re-dress the scarp on the upstream slope that was caused by cattle activity.**

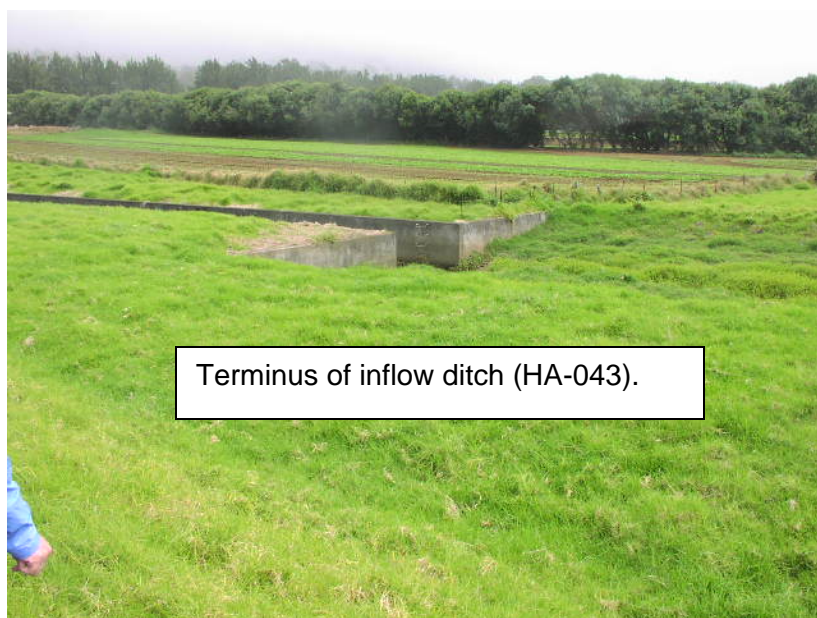
Terminus of inflow ditch (HA-043).

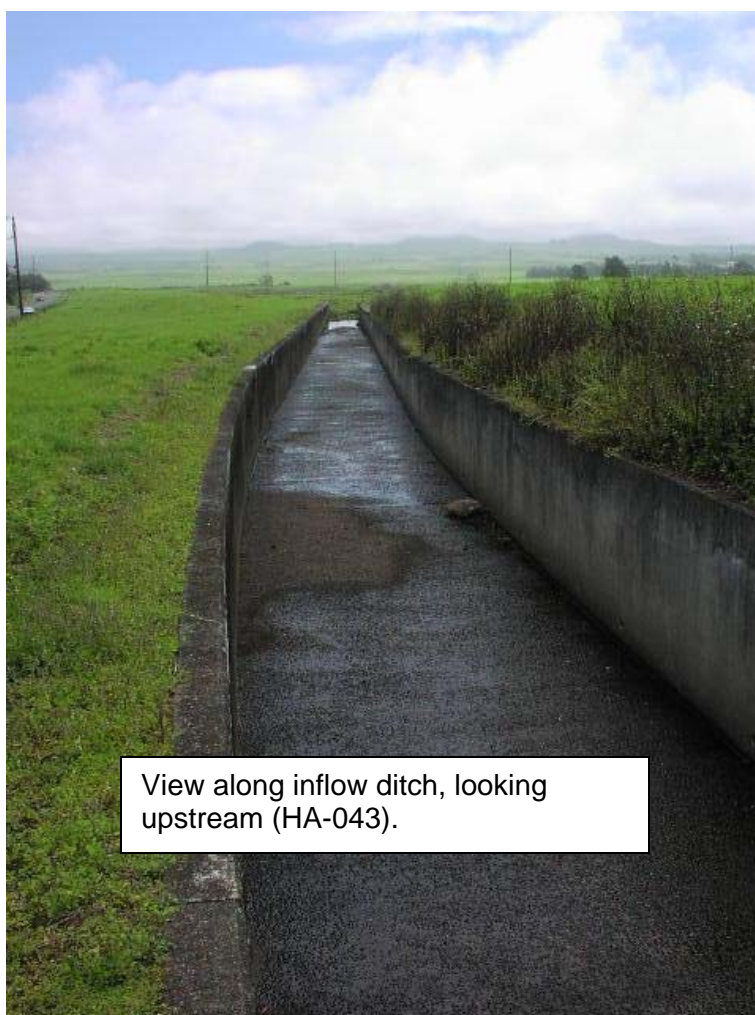
View along inflow ditch, looking upstream (HA-043).
